# Horizontal Shear Wave Imaging of Large Optics

M. J. Quarry

September 14, 2007

Horizontal Shear Wave Imaging of Large Optics  
Golden, CO, United States  
July 22, 2007 through July 27, 2007

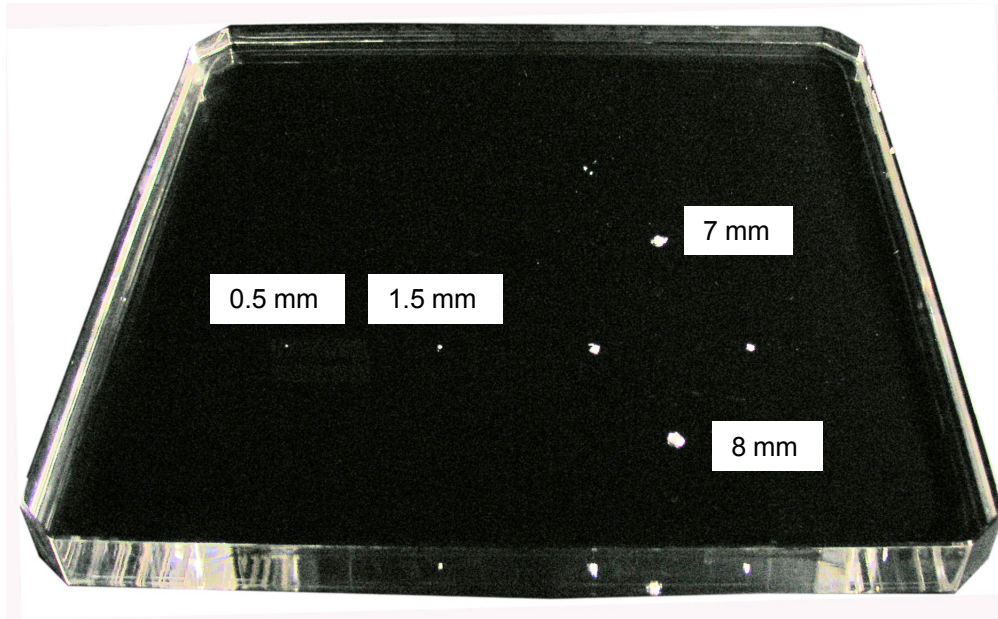
**FIGURE 1.** Photograph of a fused silica target chamber vacuum window show multiple damage sites.

The goal of the technique is to detect, locate, and size damage sites of 0.1 mm and larger with good signal-to-noise. Longitudinal and shear waves were investigated on the optic shown in Fig. 1. Sensors were placed along the sides of the optic near the vacuum surface as shown in Fig. 3. Longitudinal modes were found to have problems with multiple reflections. Mode conversions from the defect and from reflections at the top and bottom surface of the optic created multiple reflections from any damage sites as well as the back surface.

Images were produced with 10 MHz horizontally polarized shear wave sensors using data taken on the optic shown in Fig. 1. Damage is generally hemispherical in shape; each site has a very complex rough surface often consisting of a “crush” zone and other areas with a combination of radial and circumferential cracking. Damage sites ranged in size from 0.5 mm to 8 mm in diameter. Each damage site was successfully imaged.

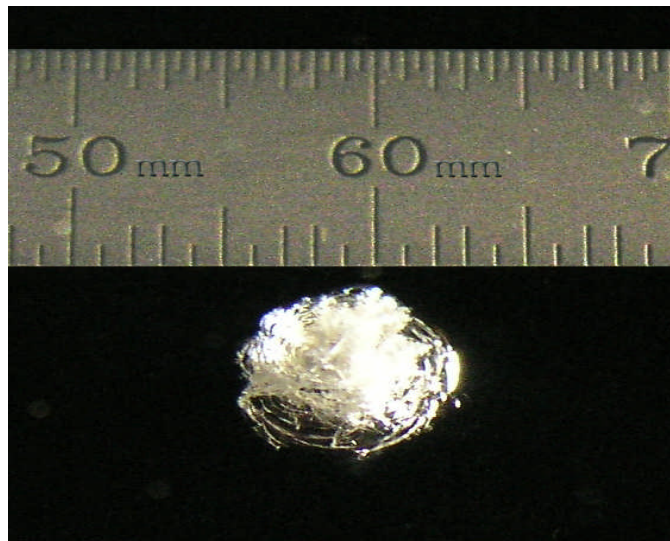
**FIGURE 2.** A 7 mm laser damage site is shown.

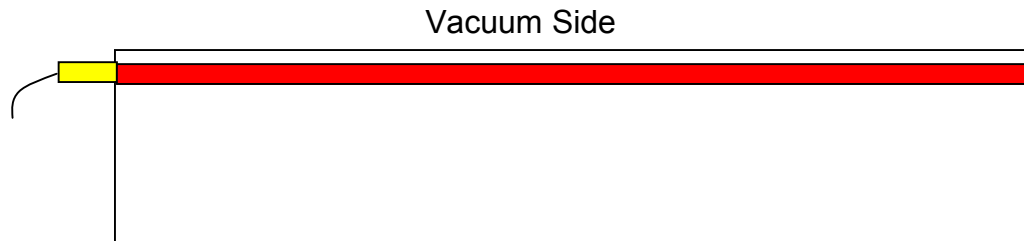
**FIGURE 3.** Sensors were placed at the side of the optic as close to the vacuum side (where laser damage occurs) as possible.

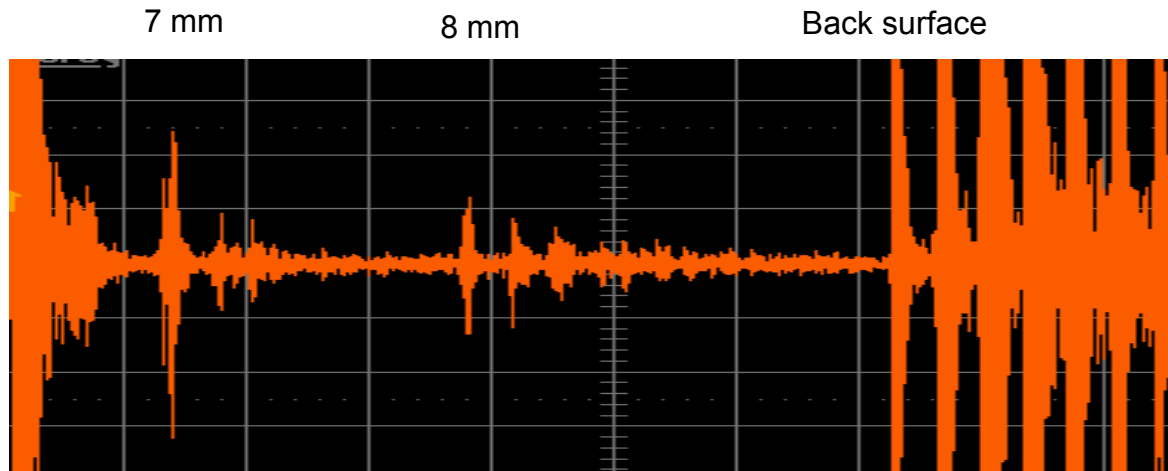
**FIGURE 4.** A 5 MHz longitudinal wave detects 7 mm and 8 mm damage sites, but many multiple echoes exist from the damage sites and from the back surface.

Directivity of the transducer had a large effect on the presence and amplitude of any multiple reflections. Frequencies of 5 to 20 MHz were tested for longitudinal modes. As the frequency increased multiple reflections decreased in amplitude but were still present. The higher directivity at higher frequencies lessened any echoes bouncing off the bottom side of the optic. A sample RF waveform using 5 MHz longitudinal waves with reflections from a 4 mm defect is shown in Fig. 4. Note the many multiple reflections.

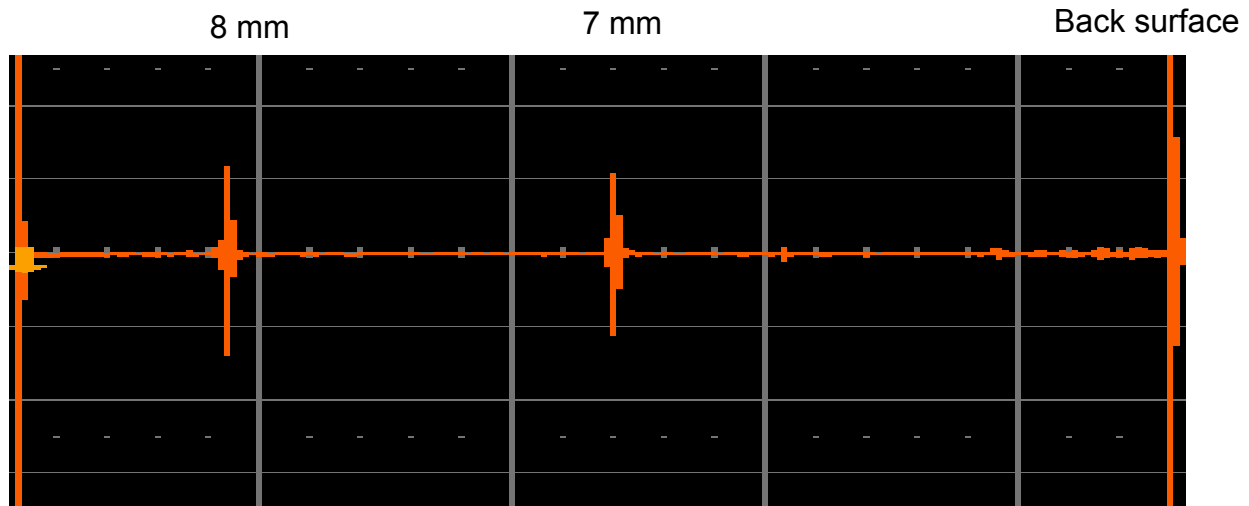
**FIGURE 5.** A sample waveform shows the detection of 8 mm and 7 mm damage sites on a fused silica optic with excellent signal-to-noise and virtually no mode conversions.

Shear waves were also tested at 5 and 10 MHz. The sensors were polarized horizontally, so that the displacement was parallel to the vacuum surface. Horizontal polarization reduced the effect of the mode conversions because it is decoupled from the longitudinal and shear vertical modes. A sample waveform is showing the detection of 8 mm and 7 mm damage sites is shown in Fig. 5. Comparing Fig. 4 and Fig. 5 shows drastic improvement in signal-to-noise for the 10 MHz horizontal shear over the 5 MHz longitudinal mode. The multiple reflections are virtually eliminated. The smaller wavelength also generates better resolution.

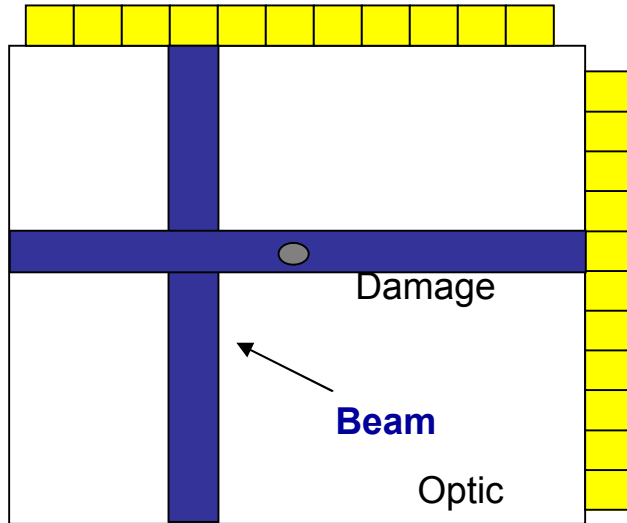
**FIGURE 6.** A schematic of the setup of transducers on an optic is shown.

10 MHz horizontal shear wave data was taken by covering the sides of the optic shown in Fig. 1. Data was obtained by multiplexing 32 elements 12.7 mm diameter placed tangent to one another. A sampling rate of 100 MS/s was used. This setup produces a resolution of 0.037 mm along the axis of propagation, but a resolution of only 6.35 mm transverse to the axis of propagation. A schematic of the setup is shown in Fig. 6. For data on two adjacent sides, one data set has high resolution in the x-direction and low in the y-direction, while the adjacent side has low resolution in the x-direction and high in the y-direction.

To make the data sets symmetrical each waveform for a transducer was replicated over the length of the aperture of the transducer. The signal is replicated every 0.037 mm across the 12.7 mm width of the transducer. The result is four 11,600 by 11,600 data sets. The Hilbert transform of each waveform is also taken to obtain the envelope. These four sets are combined into a single image by taking the product of the data sets. The result is a two-dimensional image of the surface of the optic. Measuring across the image yields the surface dimensions of the damage. It should be noted that the amplitude on the surface image does not represent the depth of the surface damage, since the ultrasound is primarily interacting with the boundary of the damage, and the reflections will have phase changes.

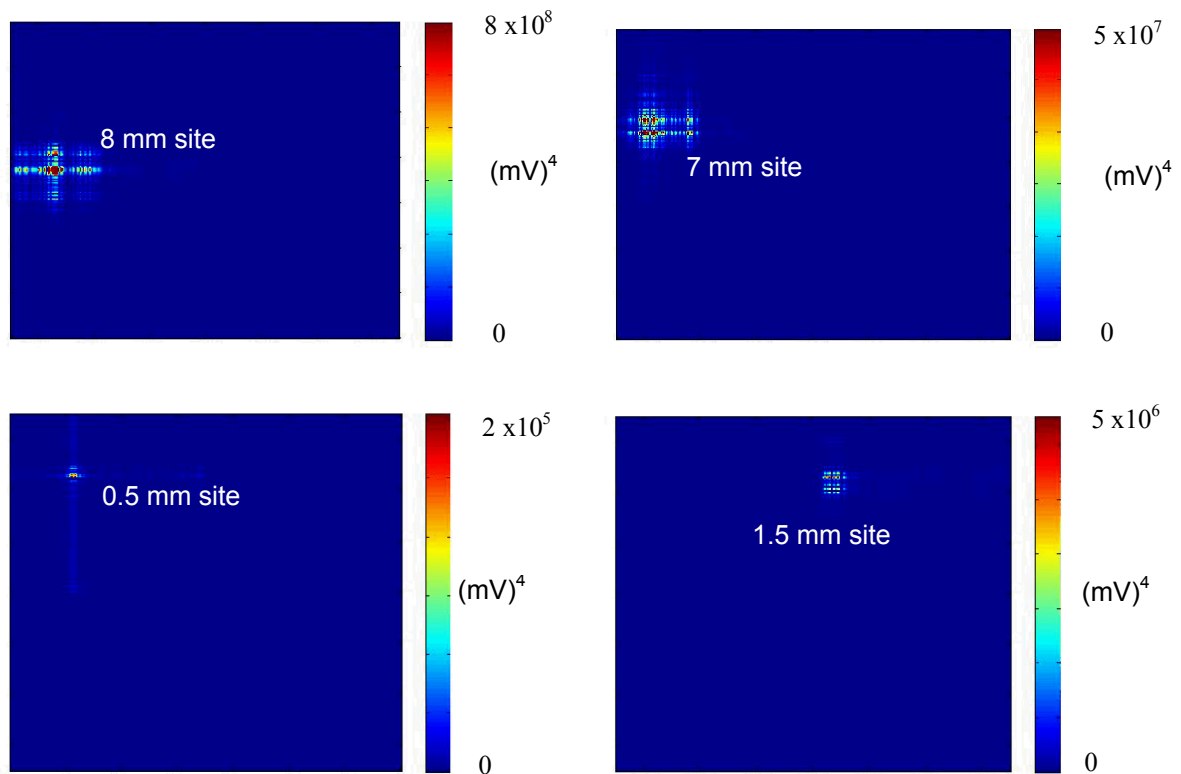
**FIGURE 7.** Horizontal shear wave images (25.4 mm x 25.4 mm) of the surface around 8-, 7-, 0.5-, and 1.5-mm damage sites show excellent signal-to-noise for detection.

Fig. 7 shows the surface images obtained using the imaging method discussed in this paper for a few of the damage sites. The images are zoomed and show an area of 25.4 mm by 25.4 mm around the damage site. The extent of the surface damage can be directly measured from the two-dimensional image. All of the damage sites were easily detected with excellent signal-to-noise. The damage sites were accurately located as well. The images gave accurate measurements compared to physical measurements with a ruler (see Fig. 2). In the 0.5 mm and 1.5 mm the damage appears to have a “shadow” in each direction. This is an artifact that is created by the replication of the waveform that is done in the processing. This does not inhibit the technique from detecting, locating, or sizing the damage. Also, the amplitude on the surface image does not correspond to actual damage depth.

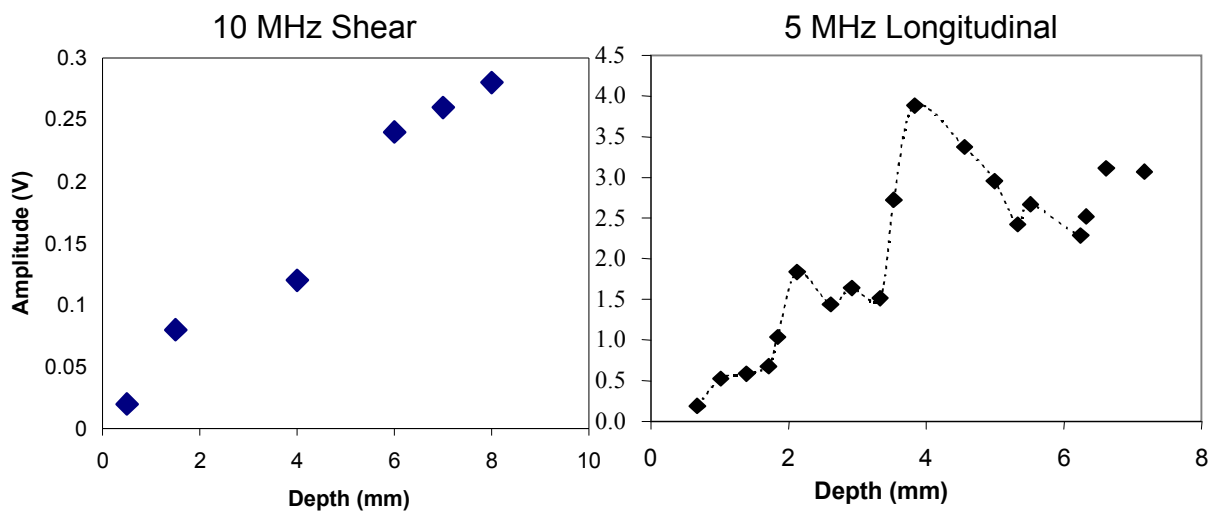
**FIGURE 8.** 10-MHz shear-wave yields a monotonic relationship with maximum laser damage depth, while the 5-MHz longitudinal-wave data has a non-monotonic relationship. Data is from sample shown in Figure 1.

Depth information can not be directly obtained from the surface image. The relationship with maximum depth of the damage and maximum amplitude of the detecting waveform was studied to determine viability of obtaining depth information from the ultrasonic data. The longitudinal wave data did not have monotonically increasing amplitude for increasing depth. The horizontal shear wave data yielded a monotonically increasing relationship as shown in Fig. 8. The result shows that an approximate maximum depth can be obtained from the shear wave technique.
